**MR. MARK'S MONTHLY MAINTENANCE TIP**

*Don't grind the pin*

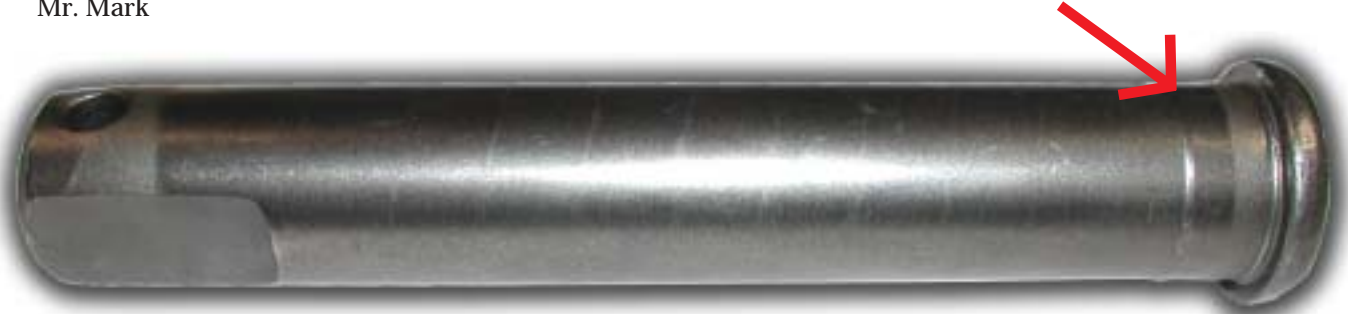
**Fig.1 - Good pin**

**Fig. 1** - This pin has not been destroyed by grinding the interference areas, which are at each end of the pin and are pressed into the side bars.

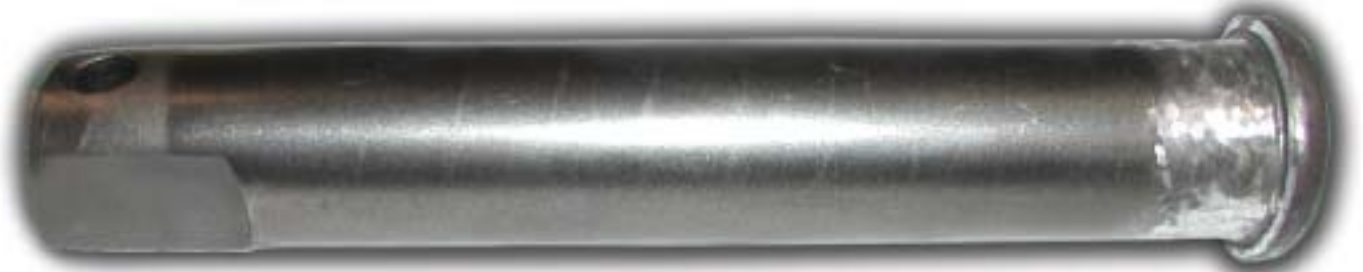
**Fig. 2 - Bad pin**

**Fig. 2** - This pin has been weakened by grinding away the "shoulder" (the raised area of the pin).

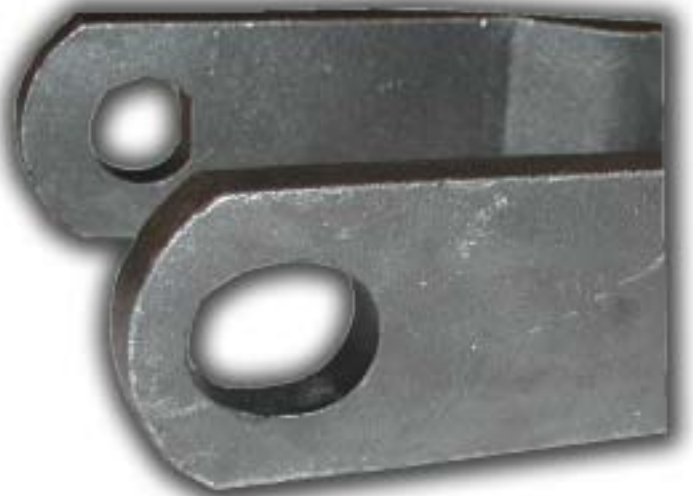
**Fig. 3 - Chain link**

**Fig. 3** - Grinding away the "shoulder" of the pin allows the pin to move around causing elongation of the side bar hole. The result of this elongation will be chain failure.
